The Owner's Guide to Piano Repair

Focus On: Repairing a Separated Back on the Vertical Piano

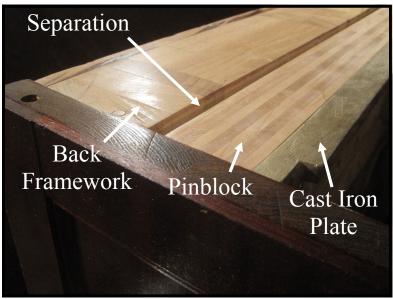
Top view of pinblock / back framework separation.

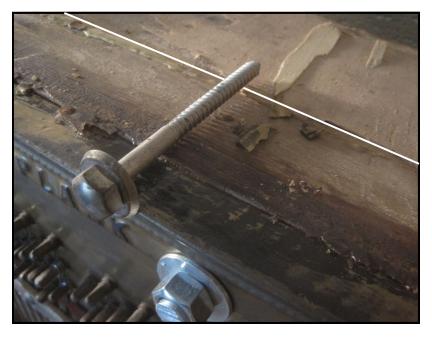
The photo left (taken during the repair of a separated back / pinblock assembly) illustrates the problem. The original lag screws (one of which is shown resting on top of the plate and pinblock) weren't able to hold things together once the glue joint failed. The white line shows where the pinblock ends and the back bracing begins. Obviously, the screws didn't

penetrate the back to a degree sufficient to hold the joint together once the glue failed. The gap had reached 3/4" by the time the repairs were done!

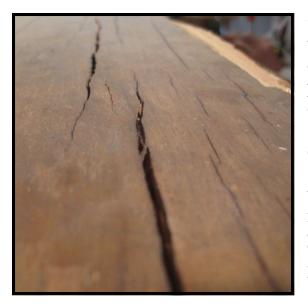
With such a covering in place, it is impossible to see the extent of the separation, let alone deal with repairing it. In the case of the maple cap glued in place in the photo to the left, the fissures which had opened up in the cap gave evidence of the separation occurring below it, but until the cap was removed, nothing could be done.

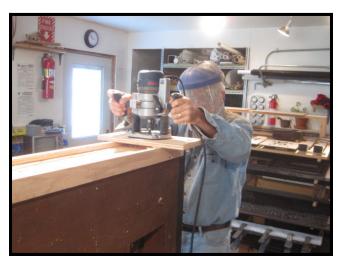
sists being pulled apart. A split lid <u>usually</u> may be pried off without serious damage to the veneer on the top of the lid, but the veneer on the underside of the lid is almost always damaged (evidenced by broken pieces of veneer seen in the top photo on page 3). A cap, however, is not veneered as are the case parts, and therefore is not so easy to pry loose. Many times a solid wooden cap (ordinarily made of maple) must be split off or even routed off (photo

right) in order to give access to the back framework and pinblock. Once repairs have been accomplished, a new hardwood cap may be produced and installed—preferably with countersunk screws to allow access in the future.

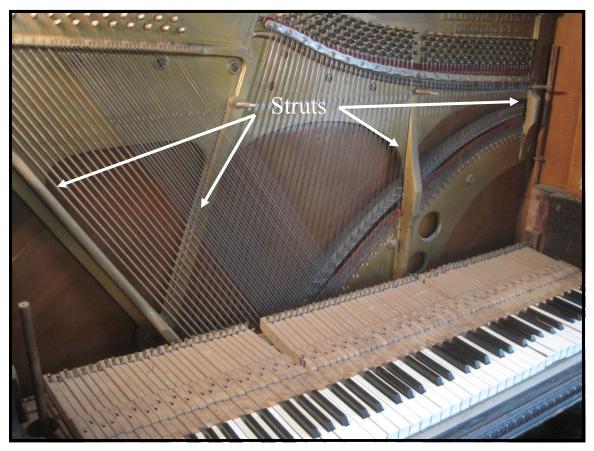
The cast iron plate revealed.

Much more serious, however, is the fact that with the top of the plate only attached to the pinblock, the tension of the strings will typically pull the plate further and further from the back. Although the cast iron plate looks as if its a solid expanse of metal when viewed from the top, it's actually not. In between the top and the bottom of the piano are struts which must resist the downward pull of the strings.

The problem is that when the top of the cast iron plate is being pulled forward and away from the back of the framework, the middle section and the bottom of the plate are still firmly held in check. If enough deflection of the top of the plate occurs, the plate can break, usually at one or more of the struts. <u>Ask anyone who has broken up an old cast iron bathtub</u>. Cast iron is very strong, but given enough force it will eventually break.

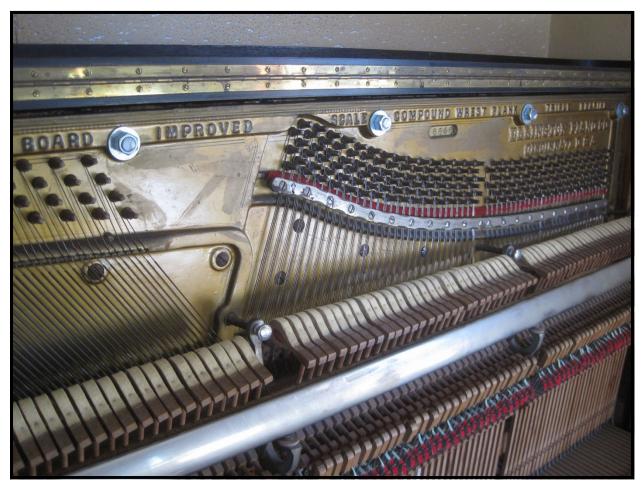
Repaired back allows tuning at A-440 for the first time in decades!
